# DOMESTIC AERIAL ROOF VISUAL INSPECTION REPORT

| Property | 14 Example Close, Wirral, CH00 0AA |
| Report reference | WDS-SAMPLE-001 |

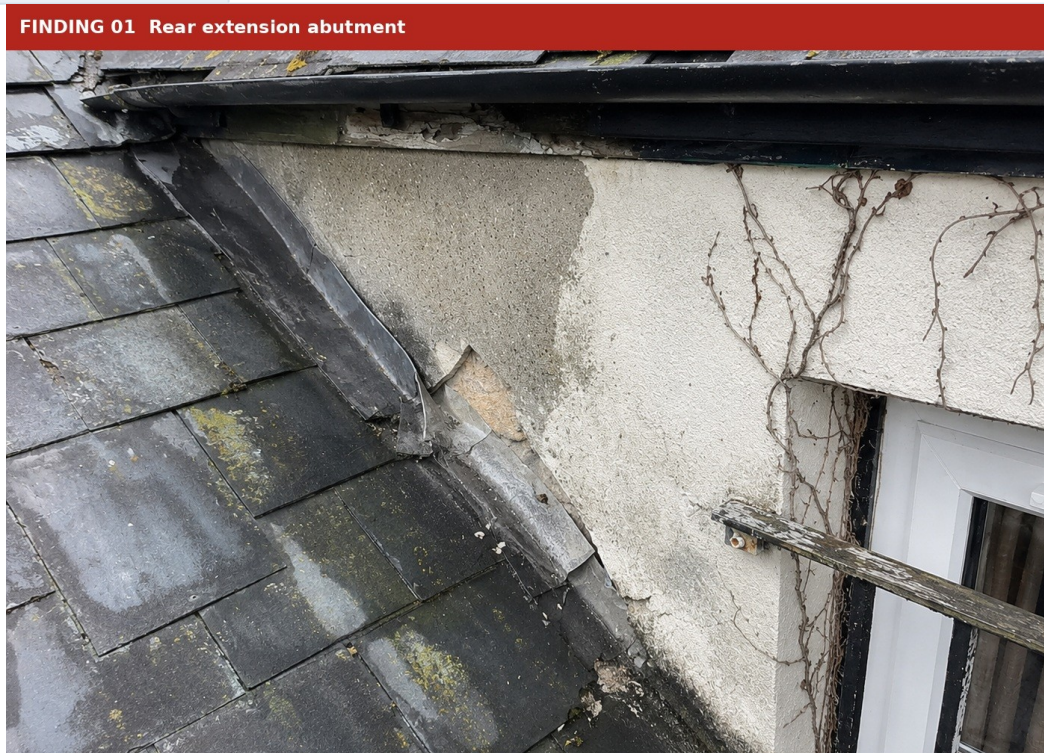
| Image reference | IMG-0006 |

| Ref | Visible condition | Priority | Suggested timing |
|---|---|---|---|
| 01 | Displaced/open weathering at rear roof-to-wall abutment | P1 | Promptly; sooner if staining is active |

## Finding 01 — rear roof-to-wall abutment

The sheet weathering or flashing at the sloping roof-to-wall junction appears locally lifted, folded and open. A small area of backing material is exposed. Dark staining and loose fragments are present at the lower end of the junction.

The opening may provide a route for wind-driven rain to pass behind the external weathering layer. The image cannot confirm active leakage or the condition of concealed materials, but the visible defect justifies prompt on-site assessment.

Ask a competent roofing contractor to inspect the full abutment, confirm the existing detail and secure or renew defective material as required. If internal damp staining is active or worsening, arrange the visit as soon as practicable and avoid unsafe temporary access.

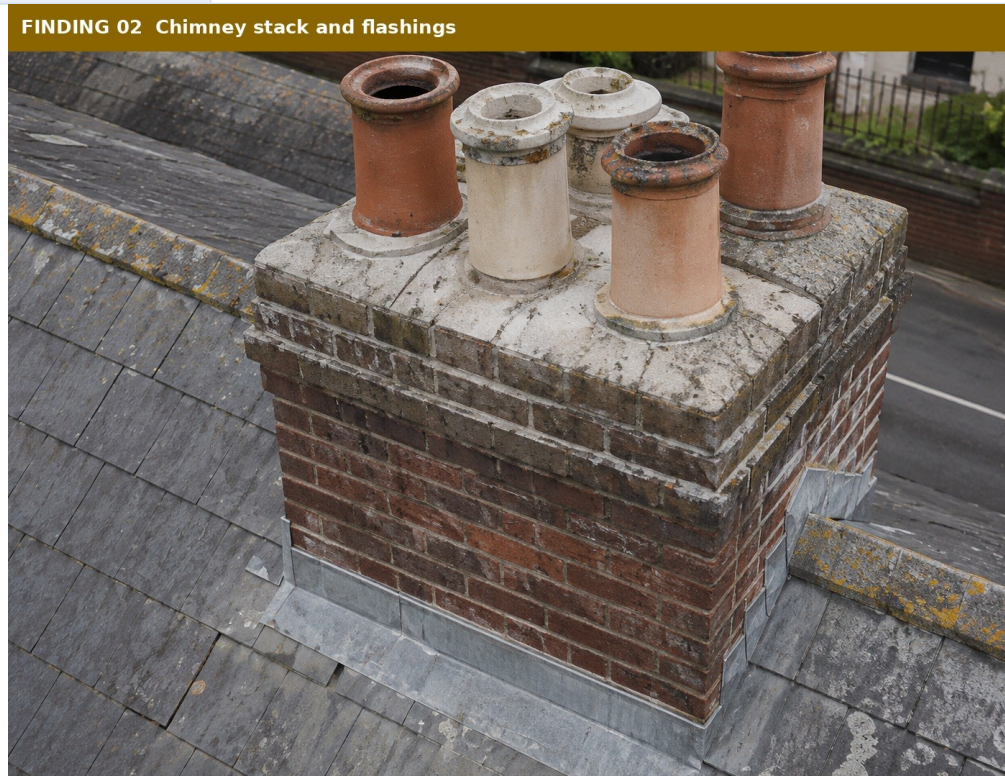
IMG-0005 • Chimney detail

| Ref | Visible condition | Priority | Suggested timing |
|---|---|---|---|
| 02 | Weathered chimney mortar/flaunching and local flashing distortion | P2 | Plan maintenance; sooner if symptoms develop |

## Finding 02 — chimney stack and flashings

Localised weathering and open mortar joints are visible within the upper brickwork. Hairline cracking and surface deterioration are present to the cement flaunching around the pots. One short section of lead weathering appears slightly distorted.

Deteriorated mortar or flaunching can admit moisture and may progress through freeze-thaw exposure. Distorted leadwork can reduce the reliability of the weathered junction. No obviously displaced masonry is visible in this image; stability cannot be assessed remotely.

Include the chimney in the roofer's on-site inspection. Ask them to check mortar stability, pot security, flaunching and all lead soakers/aprons, then quote for localised repointing or compatible repairs where required.

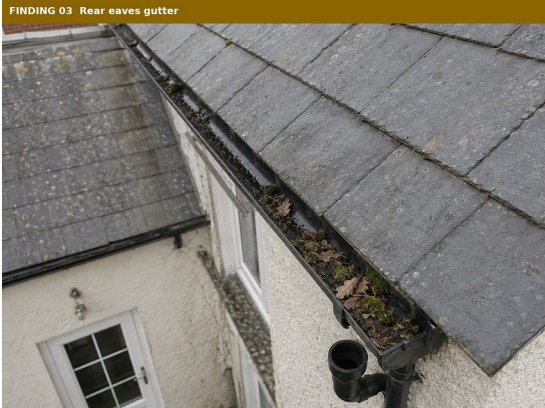
## Finding 03 — rear gutter

| Ref | Visible condition | Priority | Suggested timing |
|---|---|---|---|
| 03 | Leaf, moss and silt build-up in rear gutter near outlet | P2 | Next safe maintenance visit |

**Visible observation:** Leaf fragments, moss and silt are accumulated in the rear gutter close to the outlet area. The outlet is not shown under flow conditions.

**Recommended action:** Arrange safe gutter clearance and check that the outlet and connected downpipe discharge freely. Review after heavy rainfall for overflow or staining.

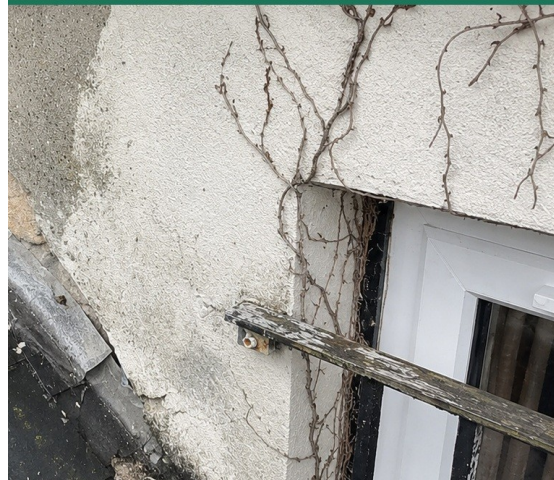
### FINDING 04 Render at junction

| Ref | Visible condition | Priority | Suggested timing |
|---|---|---|---|
| 04 | Cracked and locally missing render beside the abutment | P2 | Coordinate with junction repair |

**Visible observation:** Cracking, open edges and local render loss are visible beside the abutment and window reveal. Backing material is exposed locally.

**Recommended action:** After the abutment has been assessed and any required roof repair completed, ask a suitable contractor to remove loose material and complete a compatible weatherproof render repair.
