# DOMESTIC AERIAL ROOF VISUAL INSPECTION REPORT

| Property | 14 Example Close, Wirral, CH00 0AA |
| Report reference | WDS-SAMPLE-001 |

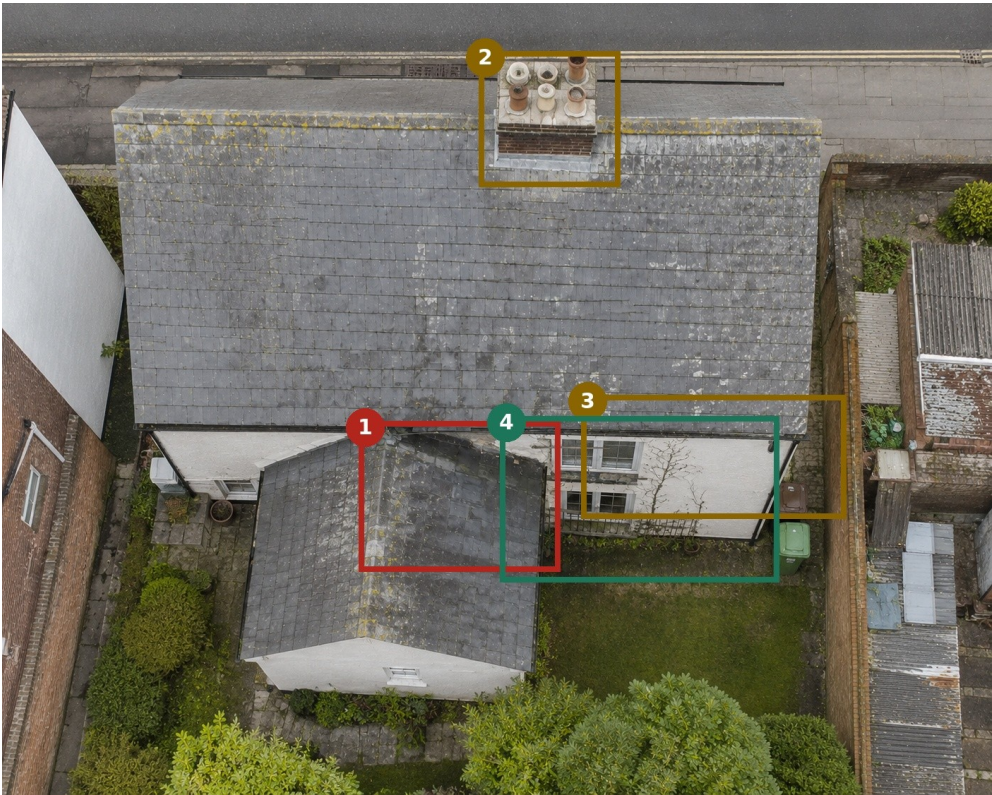
IMG-0002 • Near-vertical roof plan with finding locations

Numbered boxes link the four observations to detailed evidence pages. Overview and context images show the principal visible roof areas.
